Manhole Inspection Summary

Manhole # S21GG1019MH

Location Address: **1600 W 41ST ST**

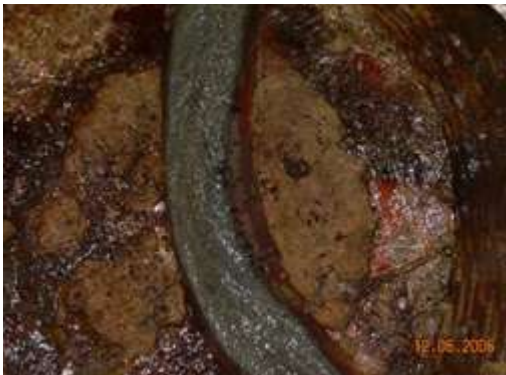
Top View

Evidence of surcharge - Bench debris.

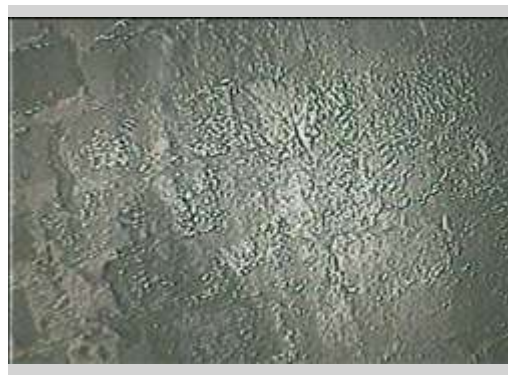
Defect

Infiltration: ☐ None ☐ Joint ☒ **Cracks** ☒ **Mortar** ☐ Roots ☒ **Wall**

Barrel infiltration.

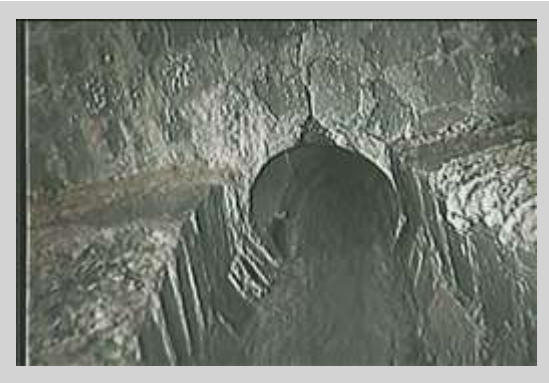
8 in. Circular Gravity Sewer Pipe Out @ 12 O'Clock

Barrel cracks and infiltration.

Infiltration: **Evidence** Pipe Seal Cond: **Cracked**

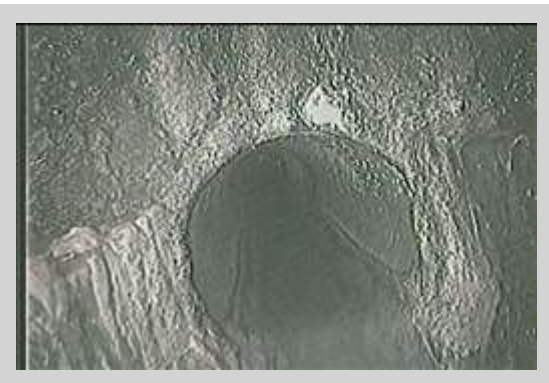
8 in. Circular Gravity Sewer Pipe In @ 4 O'Clock

Infiltration: **None** Pipe Seal Cond: **Unknown**
